UNITED STATES ENVIRONMENTAL PROTECTION AGENCY
REGION III
1650 Arch Street
Philadelphia, Pennsylvania 19103-2029

Re: Request for Information Pursuant to Section 3007(a) of the Resource Conservation and Recovery Act, 42 U.S.C. § 6927(a), Regarding Generation and Management of Hazardous Waste by Akzo Nobel Coatings Inc.
EPA ID No. VAD000019828
Reference No. C06-003

Comprehensive Compliance Monitoring and Enforcement Report

AKZO Nobel
Roanoke, VA
VAD000019828

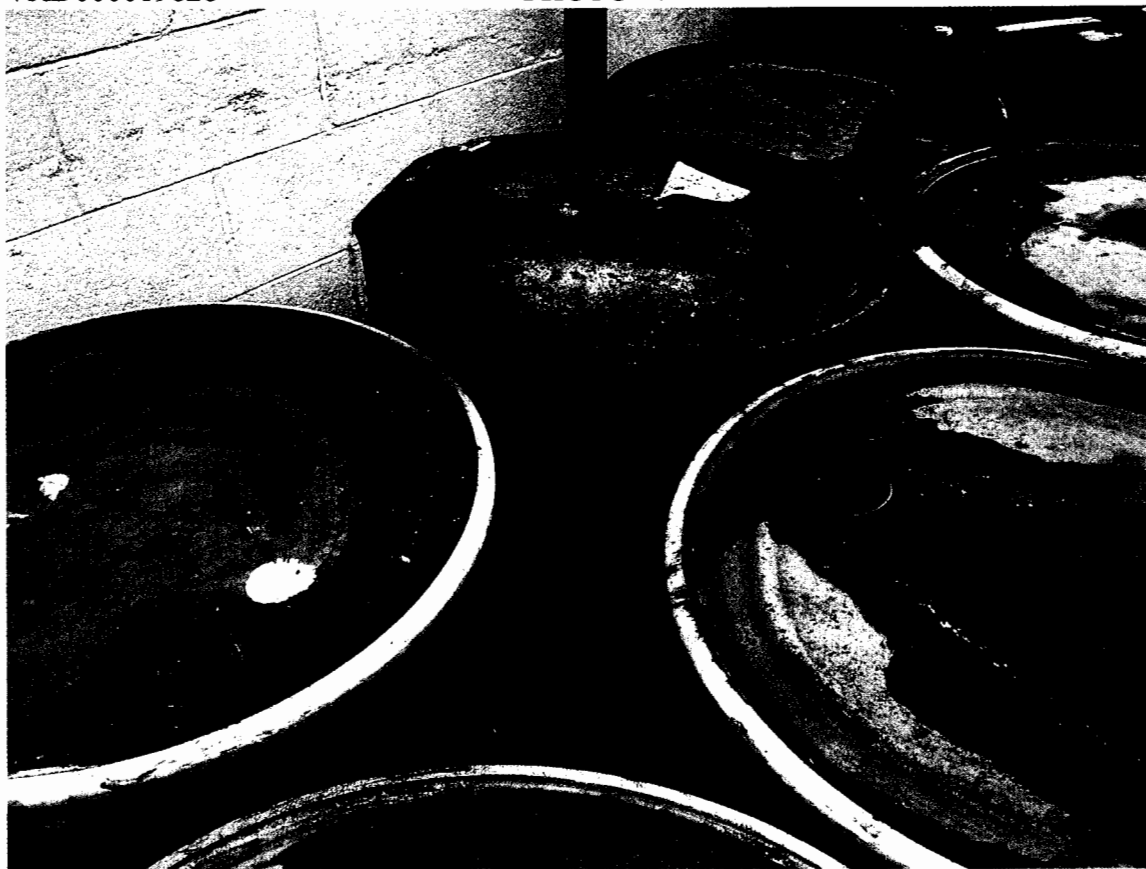
PHOTO 26

Manufacturing Building wall of the alley between QC & Mfg
Several 55 gal containers of raw materials
The green container in bad shape is labeled "ethylcellulose"

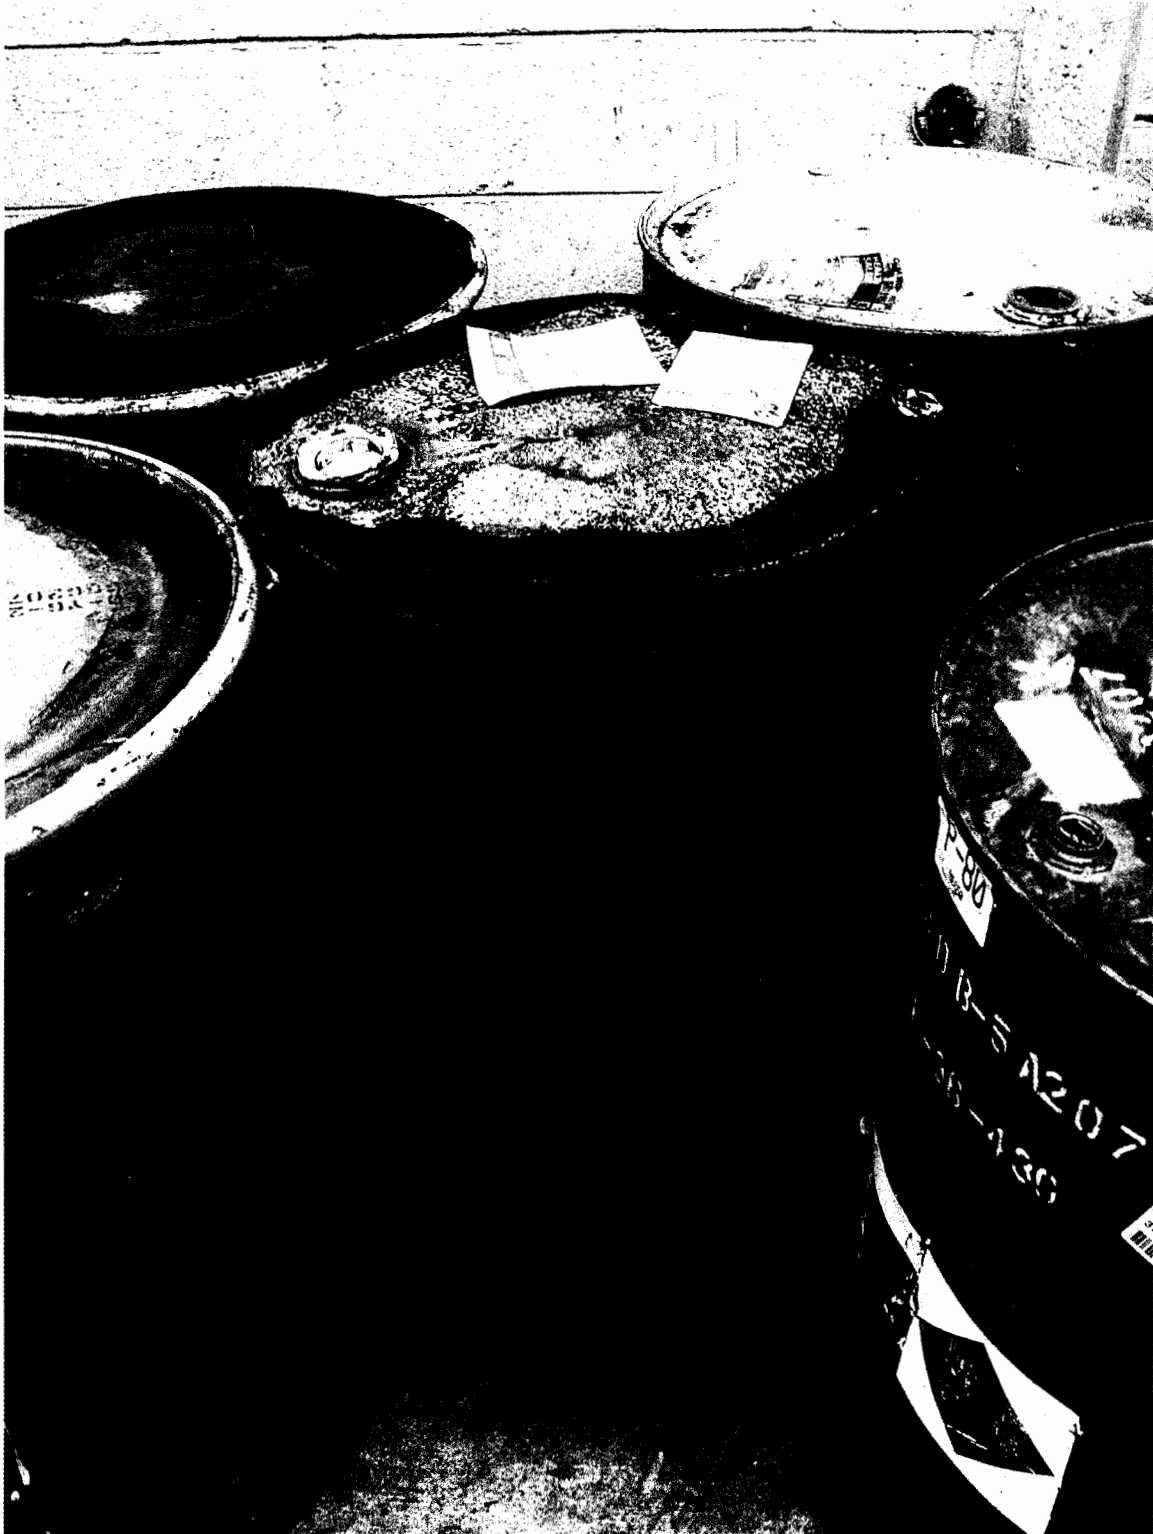
PHOTO 27

Same area as shown in PHOTO 26
Drum in center is bulging and in bad shape – No product label was visible

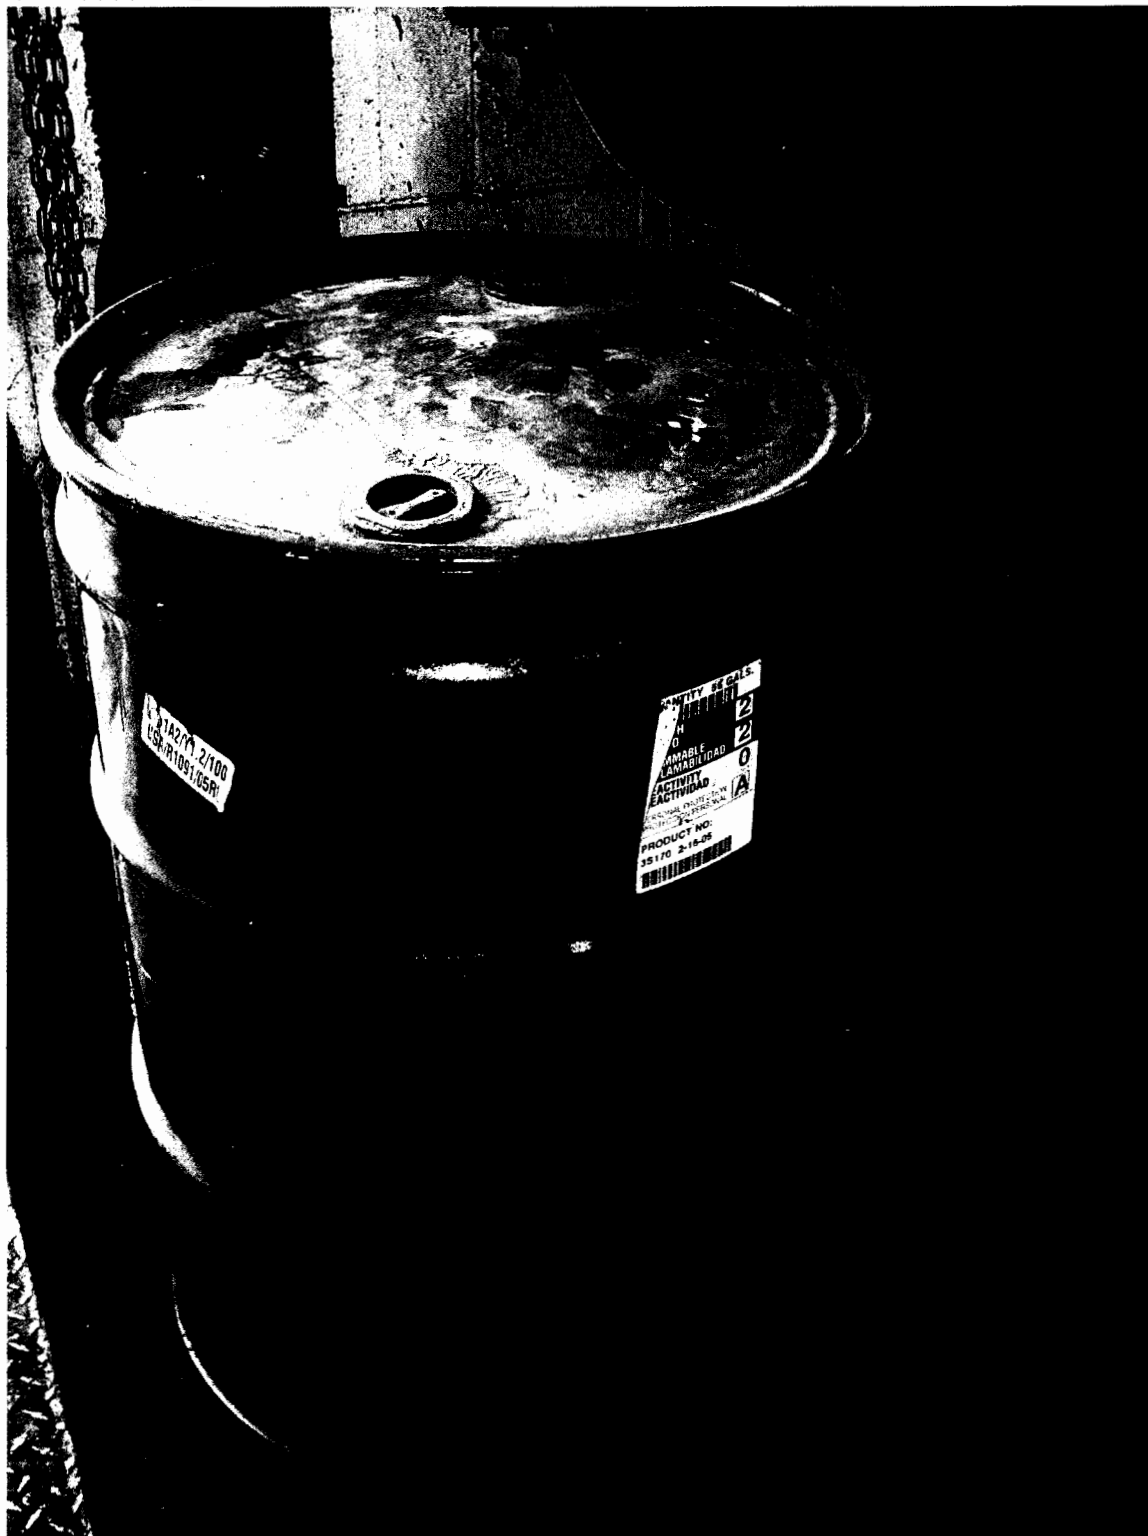
PHOTO 28

Main Manufacturing Building – Stain Section, near filter area
55 gal container of solid HW
Drum was closed, unlabeled

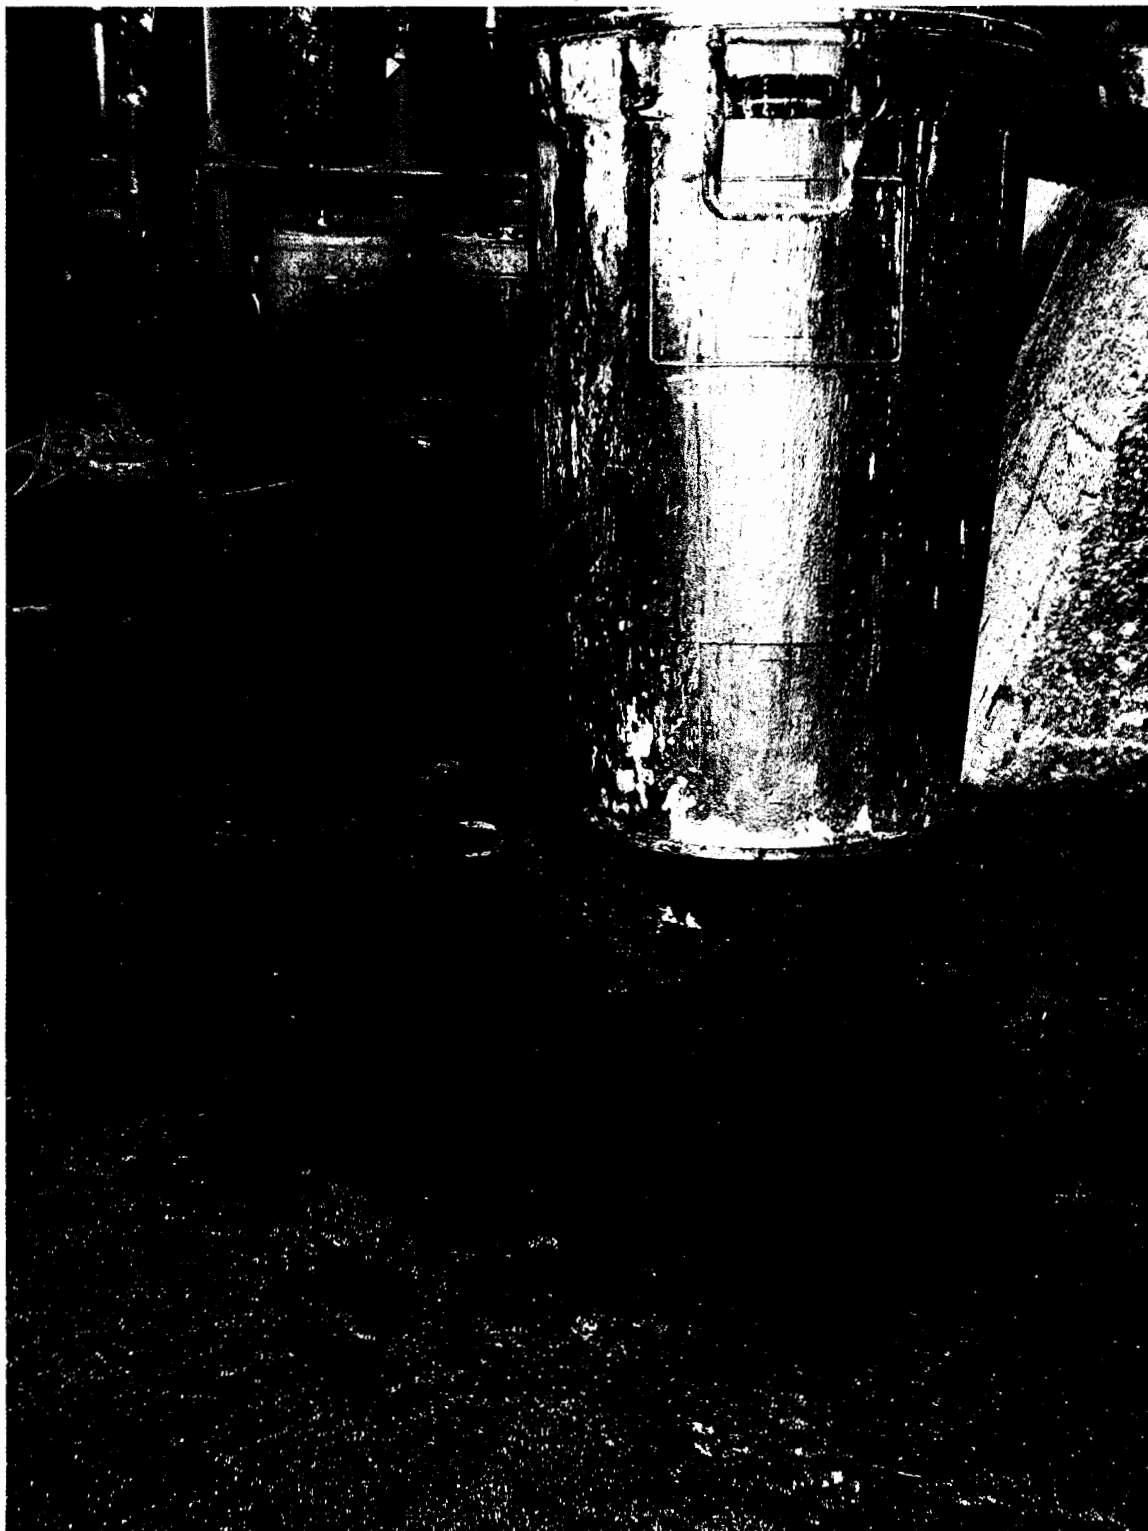
PHOTO 29

5. While inspecting the Stain Section of the Manufacturing Building the inspector observed liquid on the floor that the facility representative for this area stated was left over after product transfer and tank cleaning. (See Photographs 29 & 30) The representative further stated that the material on the floor is usually cleaned up and disposed of after transfer.
With regard to this material:

Manufacturing – Stain Section
Liquid on floor left over from tank cleaning
Mr. Rice stated this is usually cleaned up & disposed of after transfer

- a. Please provide a detailed description of the process or processes which generated the material(s) observed. State why the material(s) are not contained.

- c. Describe the contents of this material observed during EPA's April 2005 CEI, and provide the basis for your knowledge of such contents.
- d. State whether a "waste determination" and "LDR determination" was made for the material observed.

- e. If a "waste determination" and "LDR determination" were made for the material observed, state when each such determination was made.
- f. Was the material observed in Photograph 29 determined to be "hazardous waste?" If so, please state the specific EPA Hazardous Waste Code(s) associated with each such hazardous waste in this material.

- g. State in each case whether the hazardous waste determination was based on the generator's knowledge of the process that generated the waste, or on analytical results. If the determination was based on analytical results, provide any and all such results. If this waste fits a profile for a specific waste stream, provide the analytical results for the specific profile.

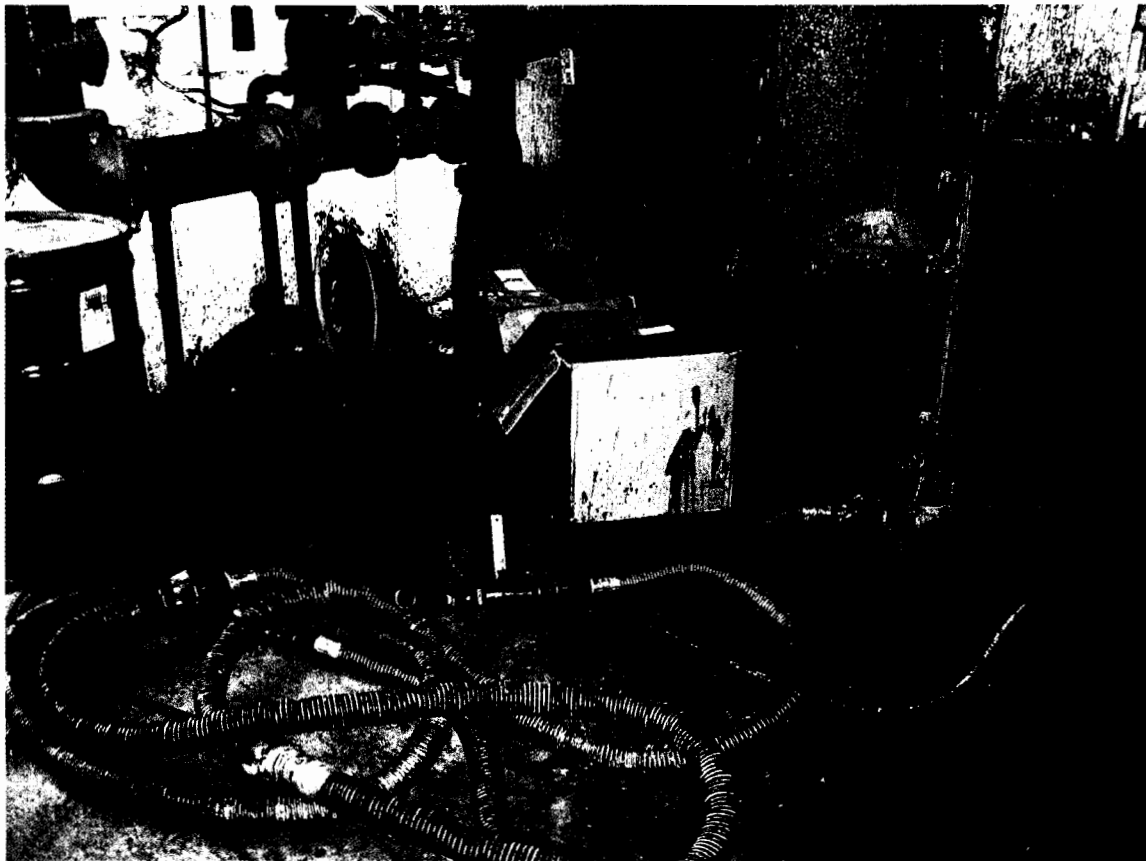
PHOTO 30

6.6 Manufacturing Solid Wastes – These wastes are mostly generated by the filtering process (PHOTO 30) and from clean ups after vessel cleaning (PHOTO 29). The filtering process causes the generation of used filters, gloves and rags. These are collected in containers as shown in PHOTOS 28, 33, 35 & 36) The container in each of these instances is not labeled or is only labeled as “Filter Drum” or “Dirty Bag Filters”. Vessel cleaning or filtering often leaves material on the floor. This material is cleaned up with booms or absorbent material and added to the solid waste container.

Manufacturing – Stain Section
Filter area – filter mechanism & associated hoses

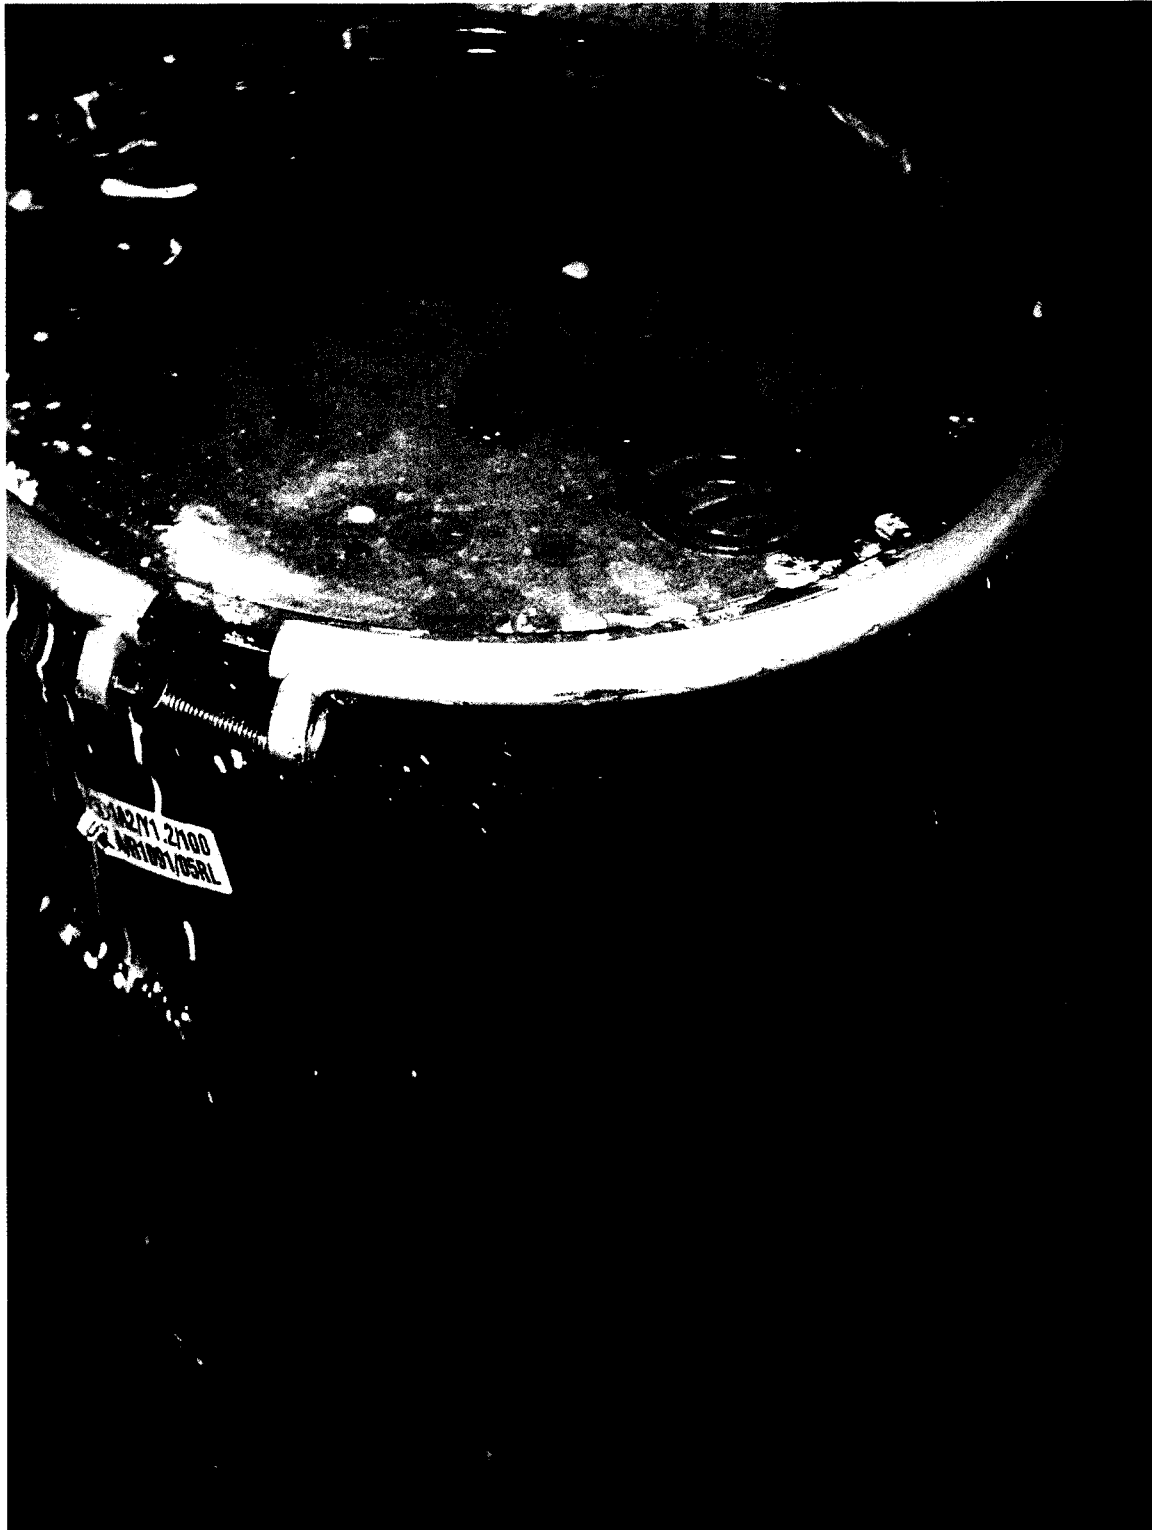
PHOTO 33

Manufacturing – Paint Section
55 gal container labeled only “Dirty Bag Filters”
Located underneath a sign “Satellite Accumulation Point”

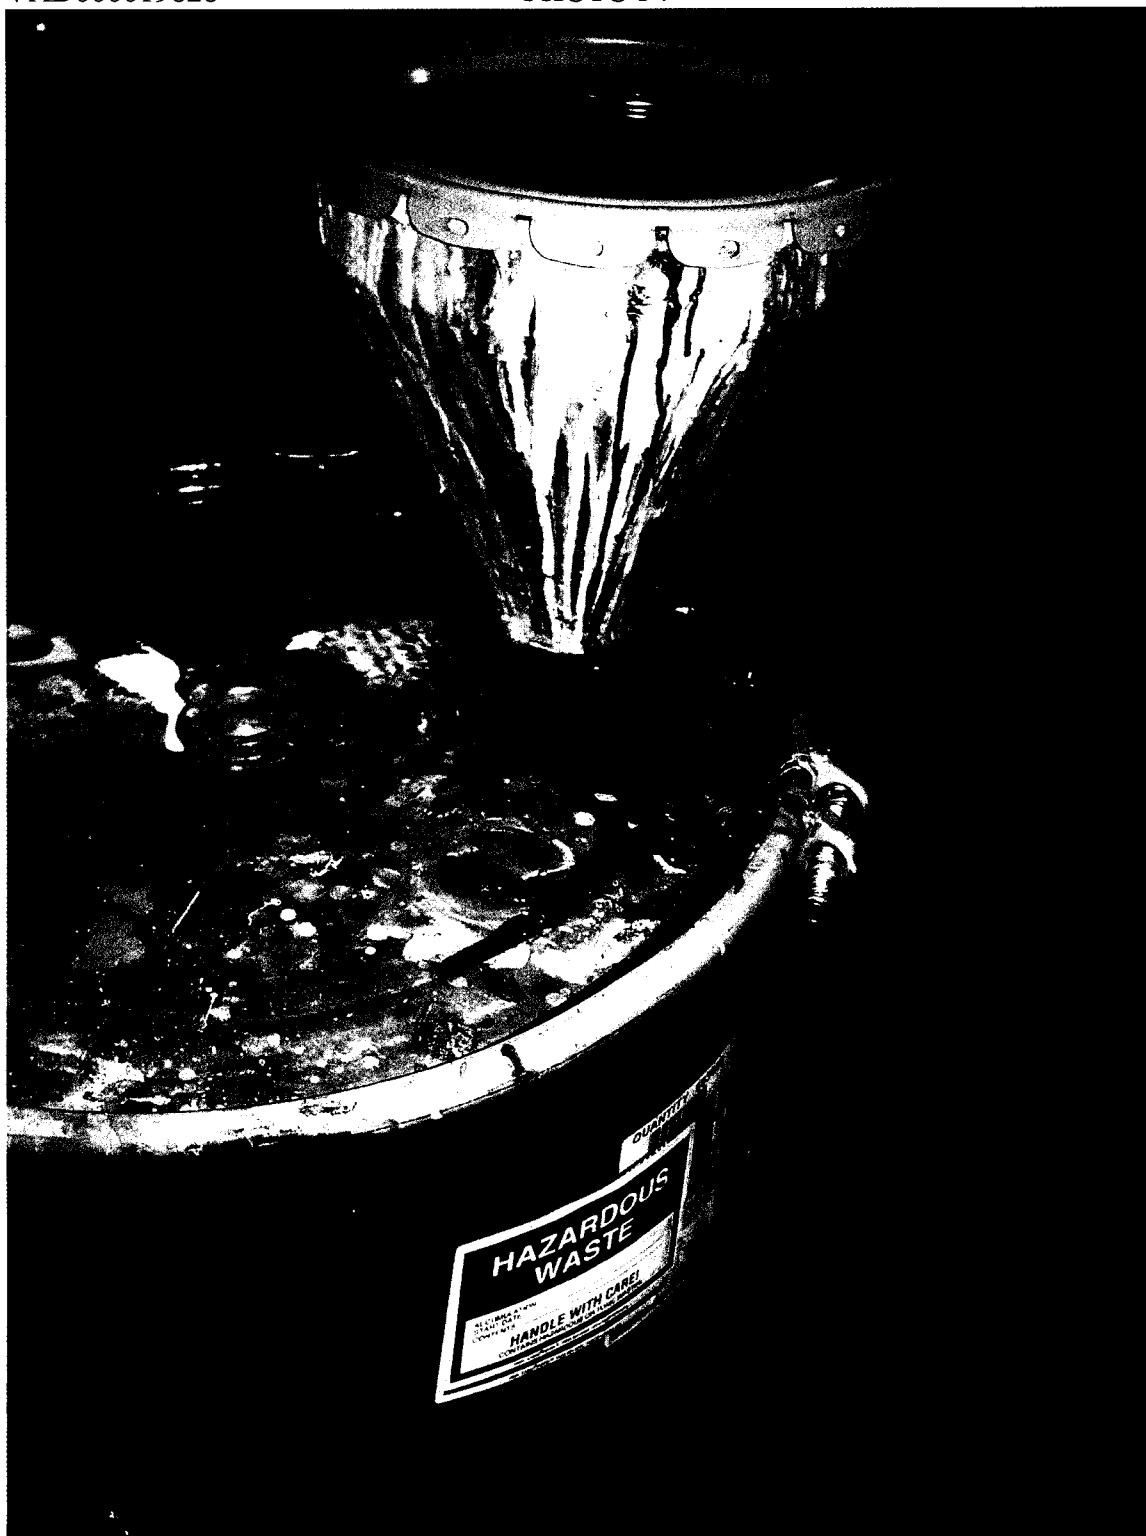
PHOTO 34

Manufacturing – Paint Section
55 gal container, closed but with a loose-fitting cover

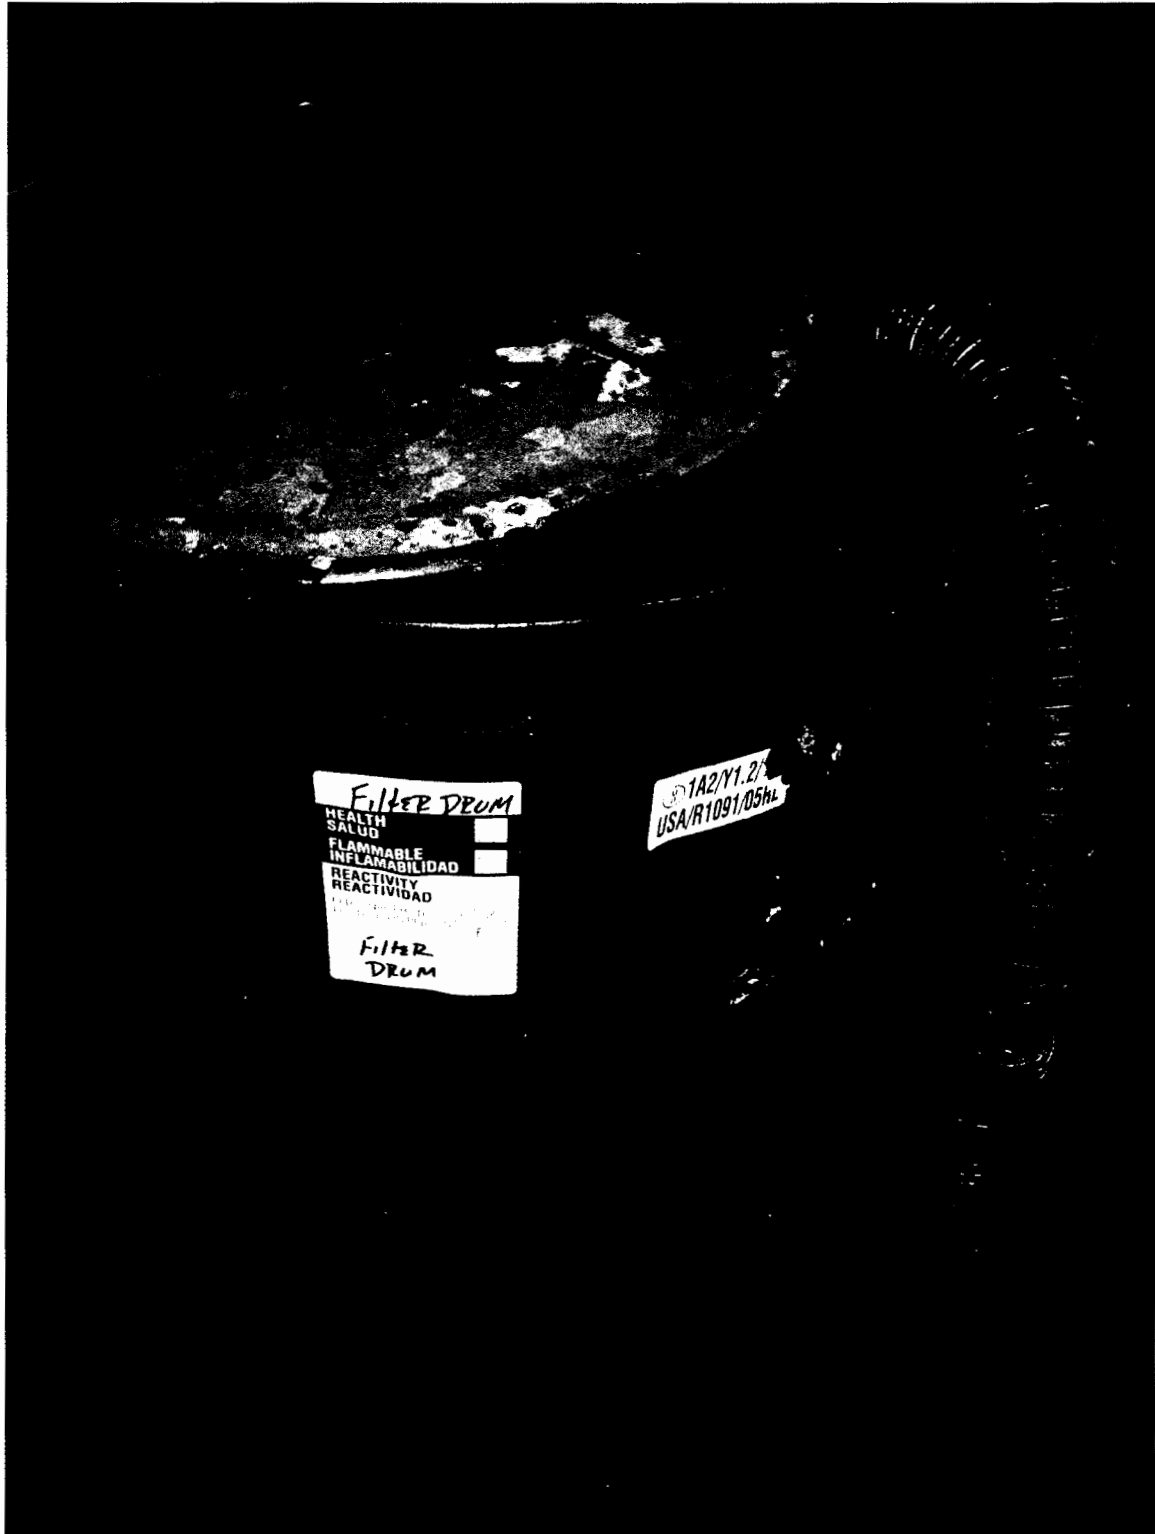
6. While inspecting the Lacquer Section of the Manufacturing Building the inspector observed a 55-gallon container labeled as "Filter Drum". It was noted that the container was not closed and that a hose was draped into the container. (See Photograph 35)

Manufacturing – Lacquer Section -55 gal container about ½ full of used filters, labeled only “Filter Drum” Representative closed the container during the inspection and stated that, when full, these drums are brought to the <90-day area as HW

- b. Describe the contents of this container observed during EPA's April 2005 CEI, and provide the basis for your knowledge of such contents.
- c. State whether a "waste determination" and "LDR determination" was made for the contents of this container.

- d. If a "waste determination" and "LDR determination" were made for the contents of this container, state when such determination was made.
- e. Were the materials in this container determined to be "hazardous waste?" If so, please state the specific EPA Hazardous Waste Code(s) associated with each such hazardous waste in this container.

- f. State whether the hazardous waste determination was based on the generator's knowledge of the process that generated the waste, or on analytical results. If the determination was based on analytical results, provide any and all such results.

- g. Was this container shipped off-site for recycle (i.e., reclaim, re-use), treatment, storage or disposal?
- h. If this container was shipped off-site, provide copies of all bills of lading, manifests (including hazardous waste manifests), shipping invoices, and LDR notices and certifications that accompanied the off-site shipment of this container.

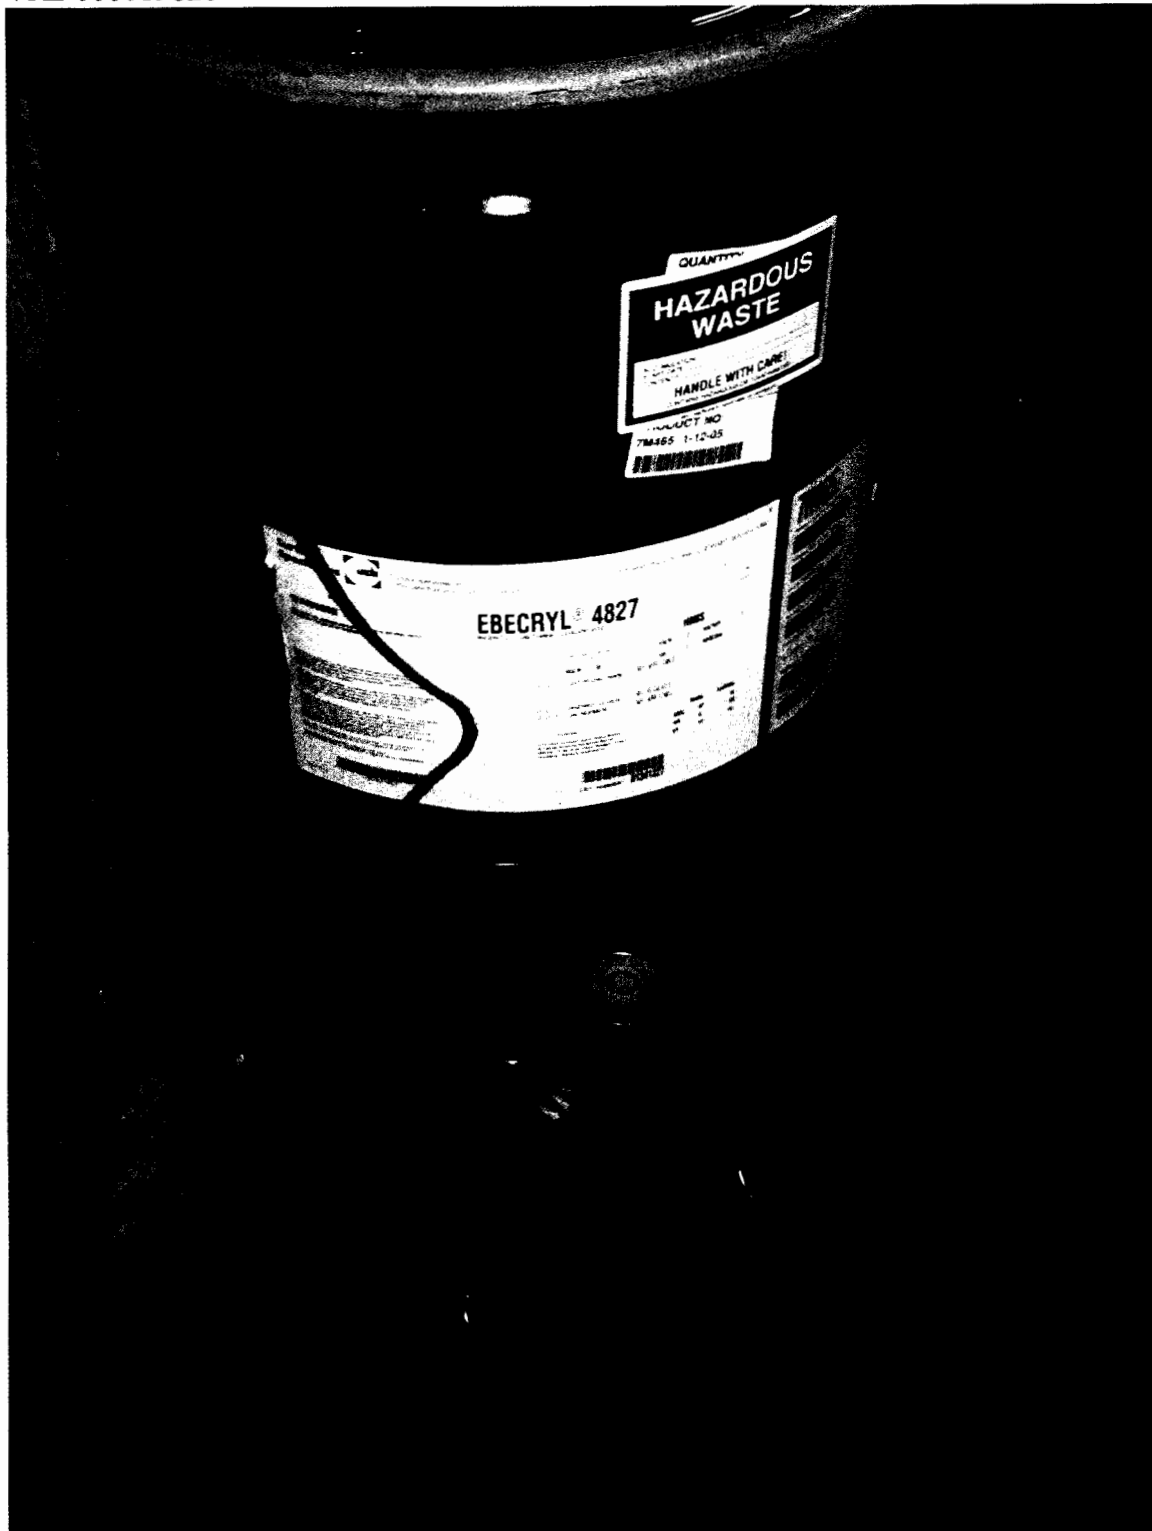
PHOTO 36

7. While inspecting the UV Manufacturing building, the inspector observed a 5-gal container that held used rags. The container was not observed to be labeled as hazardous waste. (See Photograph 36) With regard to this container:

Manufacturing – UV Building
5 gal container of used rags (gray bucket), no label

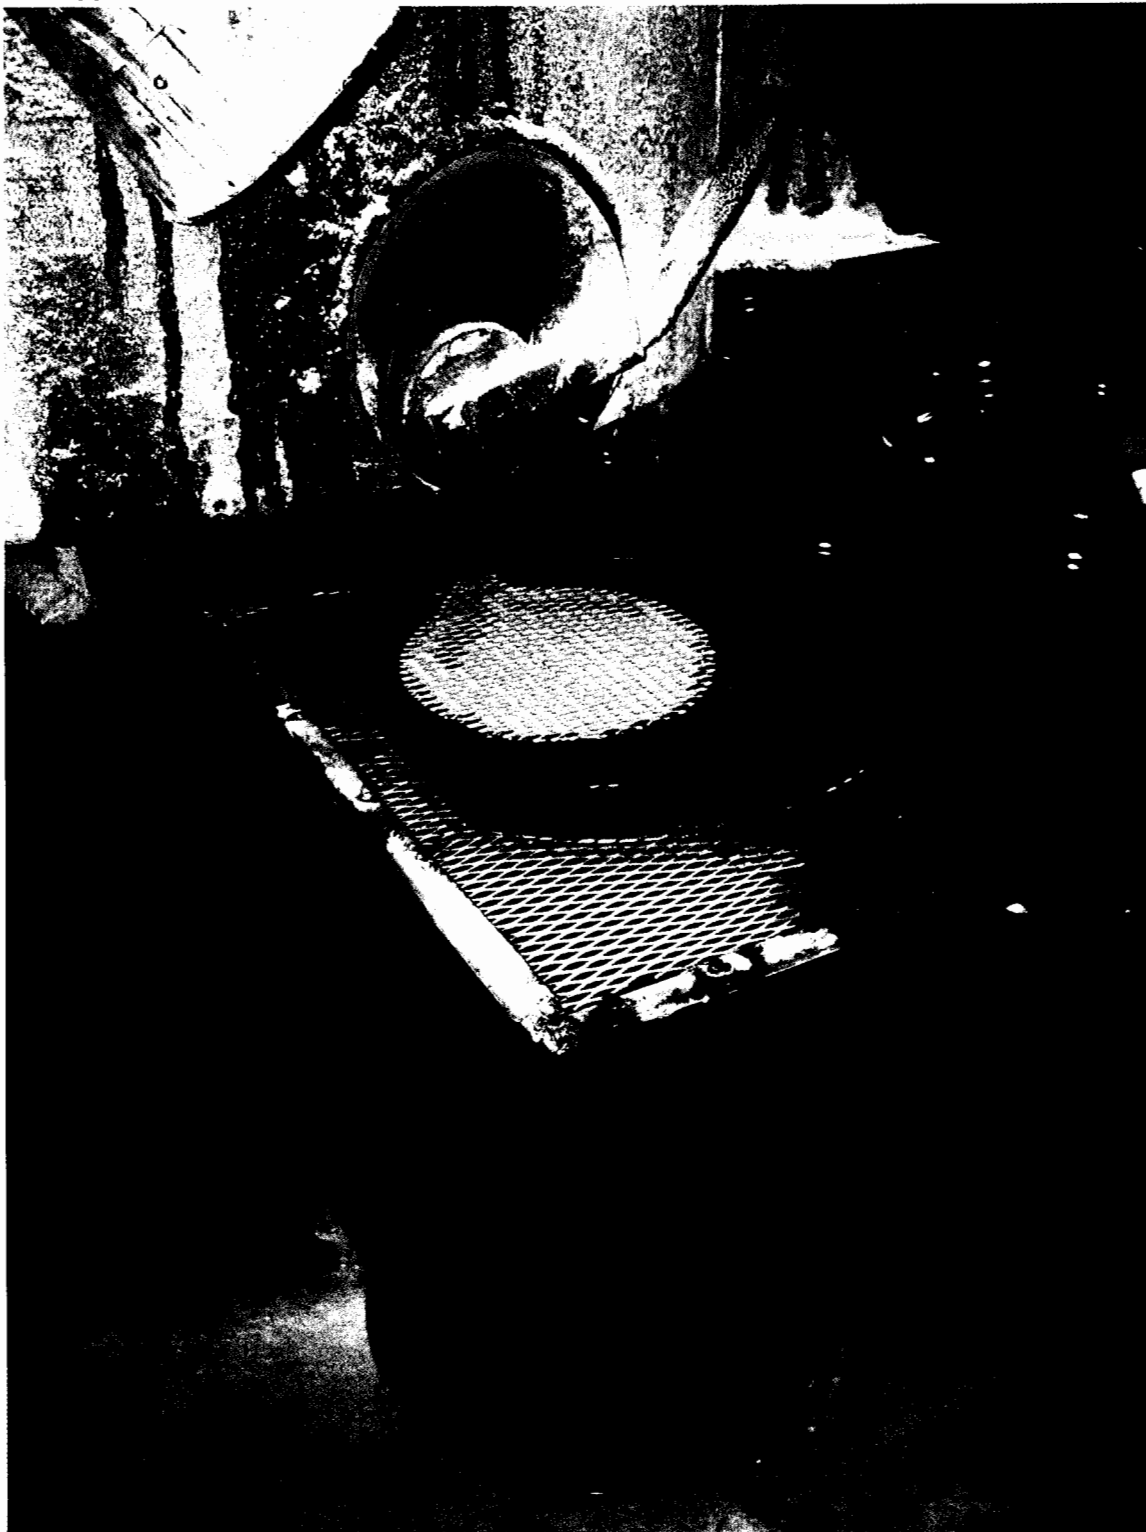
PHOTO 38

Manufacturing – UV Building
Batch screen sitting on 55 gal container

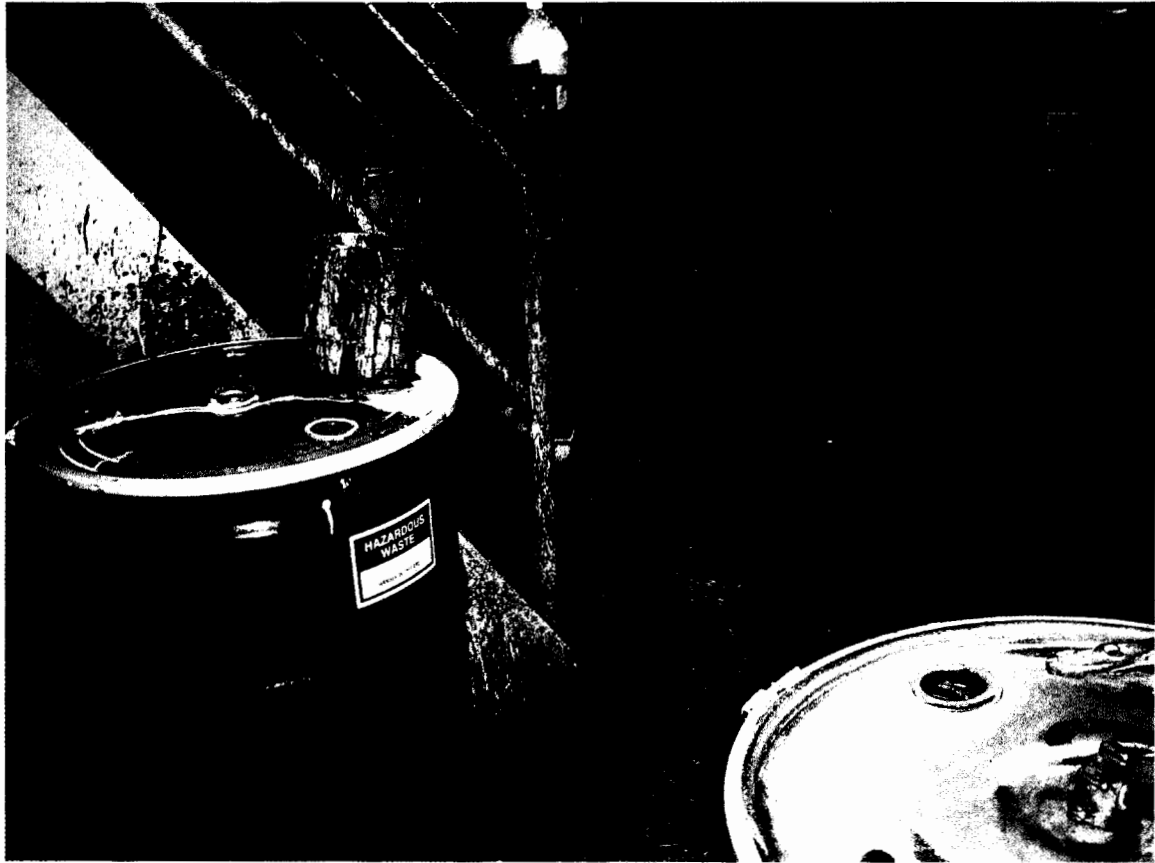
PHOTO 39

Manufacturing – Grinding Section
Overview of Satellite areas

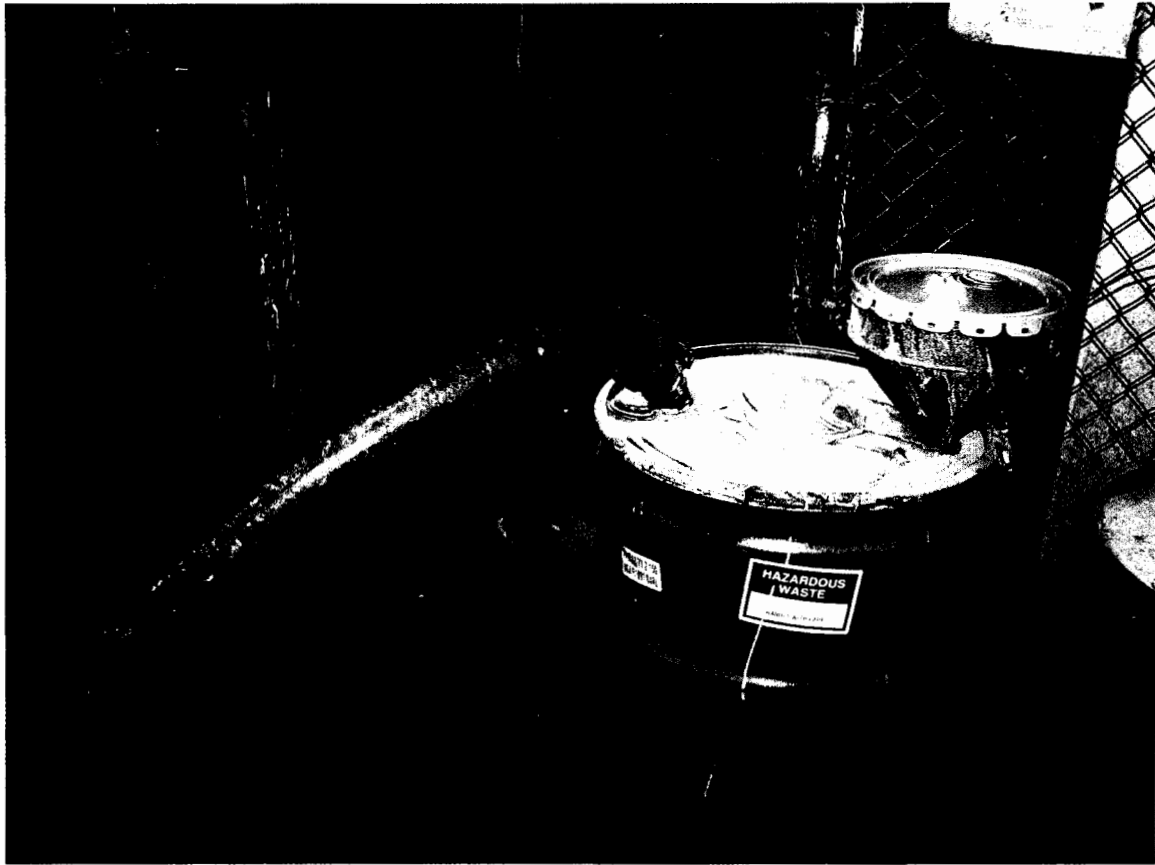
PHOTO 40

Manufacturing – Grinding Section – Color Area
55 gal container with funnel and hose connected
Other end of hose is open (top left) Gaps in fit of hose and funnel to cover

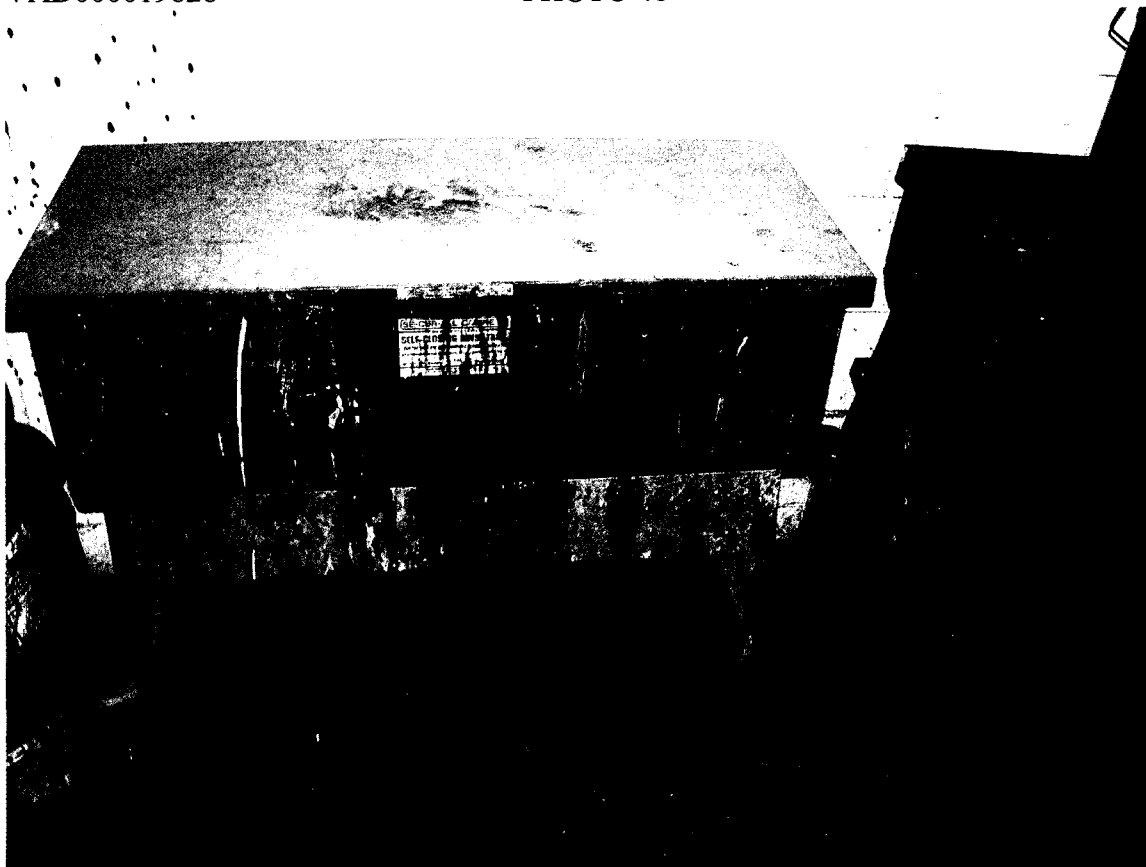
PHOTO 41

Manufacturing – Grinding Section - Wash Tank for cleaning filters
Representative stated it was mostly used by Maintenance Dept employees from a nearby building
